## Characterization and Mechanism of Device Failure due to Hollow Via Formation

Cory Hatcher, Ray Lappan, Jagdish Prasad, and Mike Engle

AMI Semiconductor, Inc.  
2300 Buckskin Rd. Pocatello, Idaho, USA 83201

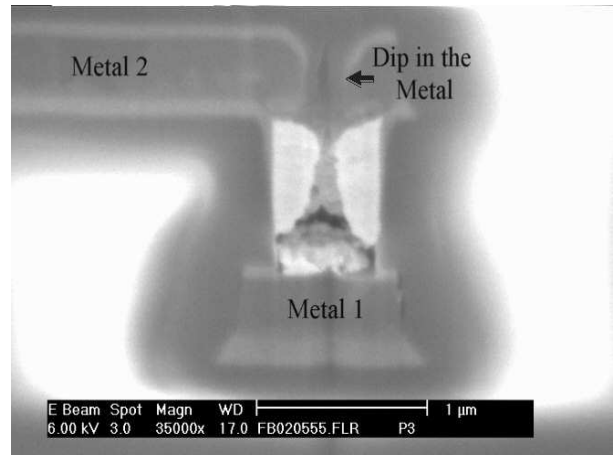
Hollow vias were detected on the IMS tester. Idd on a good part tested higher than the Idd on the failing parts. The failing parts had latent outputs that would consistently fail the faster they were clocked. This result indicates that the failure was due to a resistive node affiliated with the failing input. The failing parts were decapsulated, depassivated, and mechanically probed. The location of the lost input signal was identified and cross-sectioned using the FIB (see Figure 1). Review of the location of these defects indicated that the hollow vias are formed at the end of isolated lines (bottom metal layer) and could be located visually by what appeared to be a hole in the upper metal layer. TEM analysis of the defective die indicated that an organic material covers the sidewall and top of the metal line into the void at the bottom corner of the hollow via (see Figure 2). These observations suggest that the residual polymer from post-metal-etch can interfere with the filling of the vias during liner/barrier deposition and tungsten fill.

Figure 1: FIB cross section of hollow via

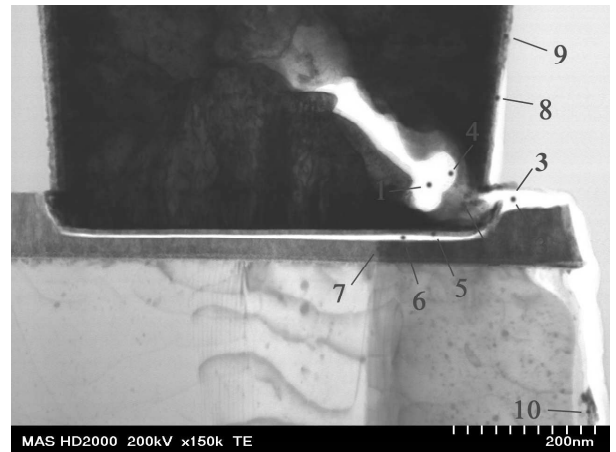
Figure 2: TEM analysis of hollow via. EDX (not shown) shows signs of carbon at locations 3 and 10, top and sidewall of metal line, respectively

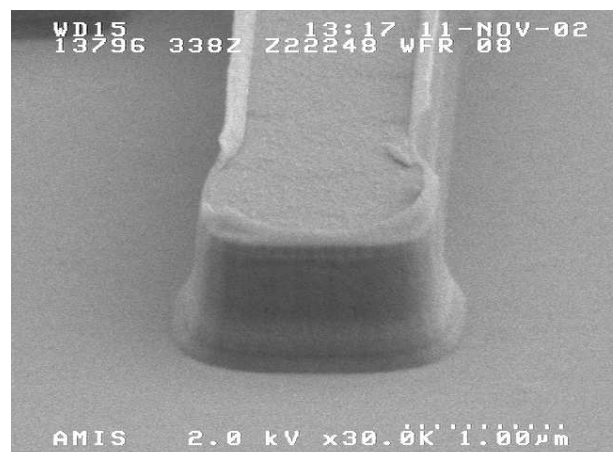
Metal etch polymer is formed to achieve anisotropic etching of the metal lines (see Figure 3). Post metal etch cleans are designed to remove this polymer, however if ineffective the polymer can remain and interfere with the formation of the via interconnects. To confirm residual post-metal-etch-polymer can cause hollow via failures a series of split lot experiments between shortened, standard, and extended post-metal-etch-wet cleaning and hydroxylamine (EKC-265) cleaning were performed. Extended and hydroxylamine cleaning produced undetectable levels of hollow vias. With reduced cleaning times polymer remained and produced hollow vias. The defect densities were so high that a random sampling of just a few sites (vias over isolated metal lines) resulted in the detection of a hollow via.

Figure 3: Metal line post resist ashing with protruding sidewall polymers
