STUDY OF DISLOCATIONS AND STRESS IN
SILICON-ON-INSULATOR TUBS USING
TRANSMISSION ELECTRON MICROSCOPY AND
FINITE ELEMENT MODELLING

A.J.McMullan,^a D.O'Mahoney,^b W.A.Nevin,^c
J.M.Gregg,^a A.T.Paxton^a

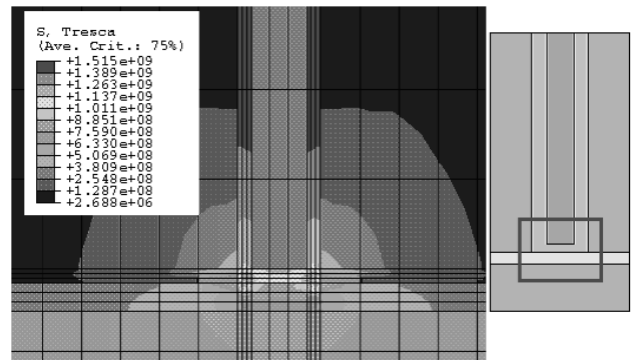
We have performed finite element calculations of the stress around the trench at various stages of the fabrication process. The stress is found to be significantly greater at the corners of the trench than the bulk silicon in the tub prior to filling with TEOS and polysilicon. In the completed structure the corners of the tubs remain at higher stress than the bulk of the tub, as was expected.

Figure 1- Completed SOI structure showing calculated stresses.

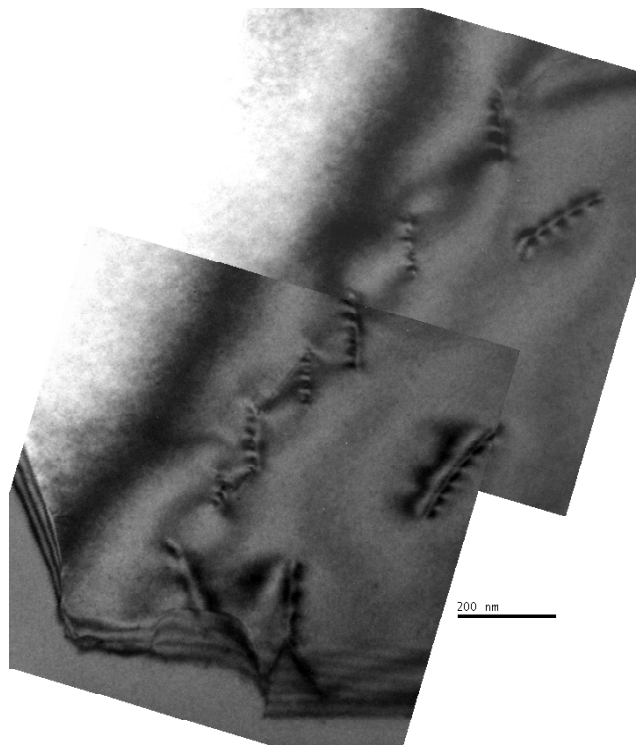
SOI wafers produced by ADB were also examined for dislocations using Transmission Electron Microscopy. Cross-sections of the bottom corner of the tubs were prepared on the FIB with care taken to avoid considerable beam damage. The sections were examined in the TEM (operating at 200kV) and two main features were noted. The corners of the tubs were not smooth but instead showed a more complex structure caused during the trenching process. This may have considerable effect on the stress at the corner. Images also clearly show dislocations propagating from the bottom corner of the tub. Figure 2 shows the dislocations observed when imaged down the (111) zone axis. When imaged down the (110) zone axis the dislocations were unable to be seen as the line vector was parallel to the zone axis. They must therefore be screw dislocations.

Figure 2- Image of the corner of the SOI tub showing dislocations propagating from it. Beam direction- (111).
