# MICROSTRUCTURE EVOLUTION AND BREAKDOWN MECHANISM STUDIES IN MOSFET WITH ULTRA THIN GATE DIELECTRICS IN NANOMETER TECHNOLOGY ERA

Chih Yuan Lu

Chih Hang Tung

Kin Leong Pey

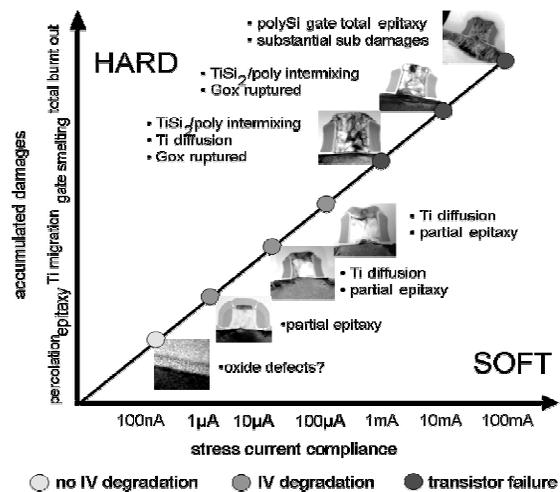
It is observed that in all the hard breakdown and some of the soft breakdown cases, the MOSFET gate structure was damaged and the degree of destruction depends on the energy pumped into the device during breakdown event (1). Fig 1 summarizes this statement. Among the physical changes observed experimentally, DBIE is believed to be the failure mechanism that is of critical importance in understanding the gate oxide breakdown. DBIE is stress polarity dependent (2). In all the cases observed, DBIE always grows from the cathode side of the stress electrode. Fig 2 shows the TEM micrograph and the corresponding stress configuration. It is believed that during the DBIE, the nucleation of the epitaxial Si starts either at the poly-Si grain/gate oxide interface or the gate oxide/Si substrate interface where the percolation path of the gate oxide breakdown terminates, depending on the stress polarity (3). High resolution TEM lattice imaging analysis had confirmed that the epitaxial hillock is indeed an extension of the crystal from the Si substrate (Fig. 2b) or the poly-Si grains (Fig. 2a). Unlike the HBD in ultrathin SiON and Si<sub>3</sub>N<sub>4</sub> gate dielectrics, in which there is always a clear DBIE formation at the BD spot, HBD DBIE formation in HfO<sub>2</sub> gate dielectric devices is less prominent and may have involved Hf silicide or silicate formation, as shown in Fig. 3. DBIE may have occurred but HfO<sub>2</sub> did not deform accordingly. Instead, DBIE has ruptured rather than caused localized thinning or bending of the gate dielectric. This indicates that the BD phenomenon in HfO<sub>2</sub> is different from that of the ultrathin SiON and Si<sub>3</sub>N<sub>4</sub> gate dielectrics (4,5).

Fig 1 A summary on the relationship between physical damages generated by a gate oxide breakdown and the corresponding compliant current levels under a constant voltage stress (CVS) condition (1).

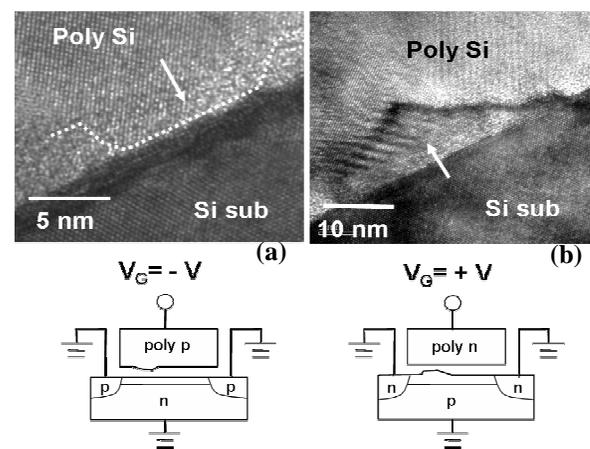
Figure 2 Cross sectional TEM micrographs of a poly-Si gate structure showing damages at various compliance current levels (a) 100nA of a Co-silicided 25Å gate oxide pMOSFET and (b) 1µA of a Co-silicided 25Å gate oxide nMOSFET. Si epitaxial extrusion indicated by the arrow from (a) poly Si and (b) Si substrate into the gate oxide is observed in both samples. The stress voltage was set at 4.4V. The arrows indicate the Si epitaxy (2).

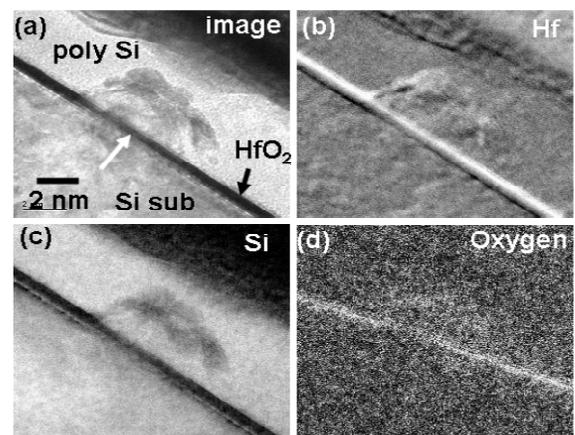
Figure 3 Cross section TEM on post hard breakdown nMOSFET device with HfO<sub>2</sub> gate dielectric, (a) bright field TEM image showing the breakdown spot (indicated by white arrow), EELS mapping with (b) Hf, (c) Si, and (d) oxygen (3).
