Fungal Influenced Corrosion in Post-Tension Structures

by Brenda Little and Roger Staehle

This paper describes the effect of fungi on the integrity of post-tensioned tendons with respect to the occurrence of stress corrosion cracking (SCC). The occurrence of SCC is interpreted in terms of organic acids produced by fungal metabolic activity.

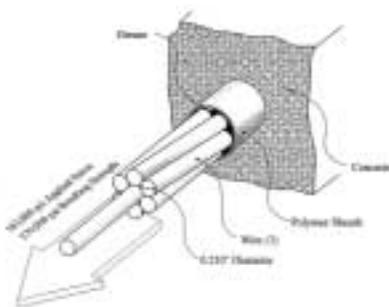
Inoculation—Tendons in this study were removed from the building during a routine stairwell cut. Each tendon consisted of a seven-wire cable in a polyvinyl chloride sheath (Fig. 2a). Each of the seven wires had a diameter of 0.53 cm. Six wires were wrapped around a central core wire. The steel

FIG. 2. (a, left photo) Tendon detail; (b, right photo) Sheathed tendons after inoculation.

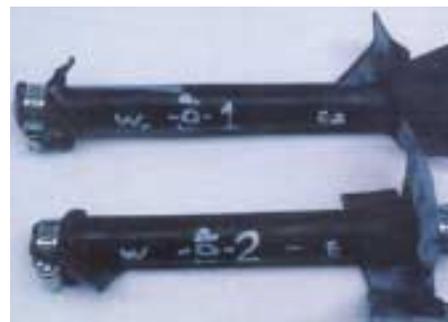
secured with a clamp (Fig. 2b). Sections were refrigerated at 4° C from time of collection until inoculation. *Fusarium* sp., *Penicillium* sp., and *Hormoconis* sp. were maintained on potato dextrose agar (PDA).

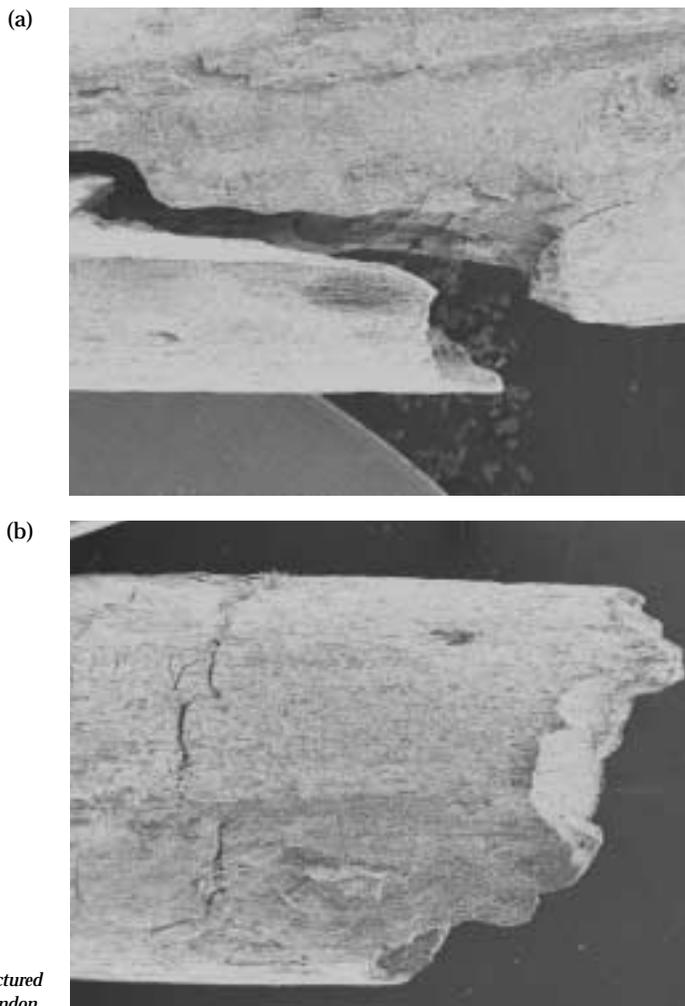
This study was undertaken after the failure of a single post-tensioned cable in a multi-story building. Figures 1a and b indicate typical fractured surfaces found on wires of tendons taken from the building. Filamentous fungi, including *Fusarium* sp., *Penicillium* sp., and *Hormoconis* sp., were isolated from the lubricating grease and the grease was consistently acidic as measured with pH indicating paper. Experiments were designed to determine the role of *in situ* fungi in the observed SCC.

FIG. 1 (a) and (b) Fractured wires from tendon.

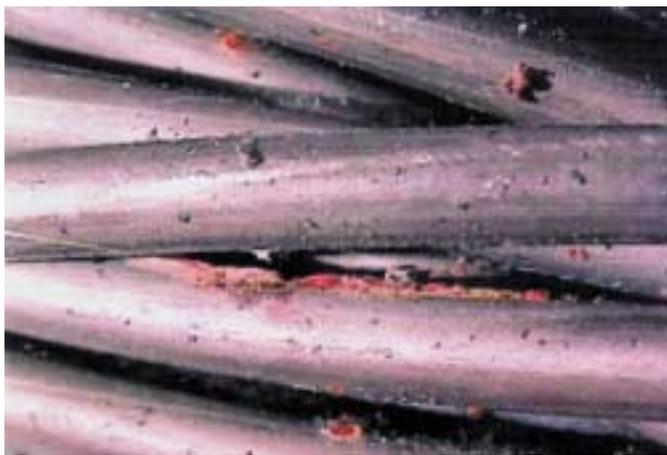
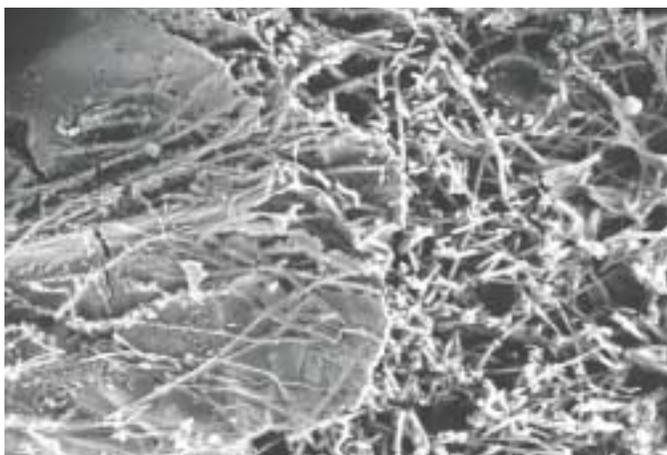
Fig. 3. (a, top photo) Fungi and corrosion products on inoculated tendon; (b, bottom photo) Fungi and corrosion products on inoculated tendon.

Localized corrosion was observed for all inoculated tendons. In all cases, shallow craters were located under corrosion products. Cracking in association with the craters was observed on two wires from a single tendon. Photographic and ESEM observations of inoculated tendons documented extensive fungal growth in association with localized corrosion (Fig. 3a & b). Petri dishes inoculated with grease from the corroded areas were positive for *Fusarium* and *Hormoconis*. There were no indications of chloride in EDS spectra of the grease. Four FTIR spectra collected from a single inoculated tendon demonstrated varying degrees of degradation Spectra are arranged in

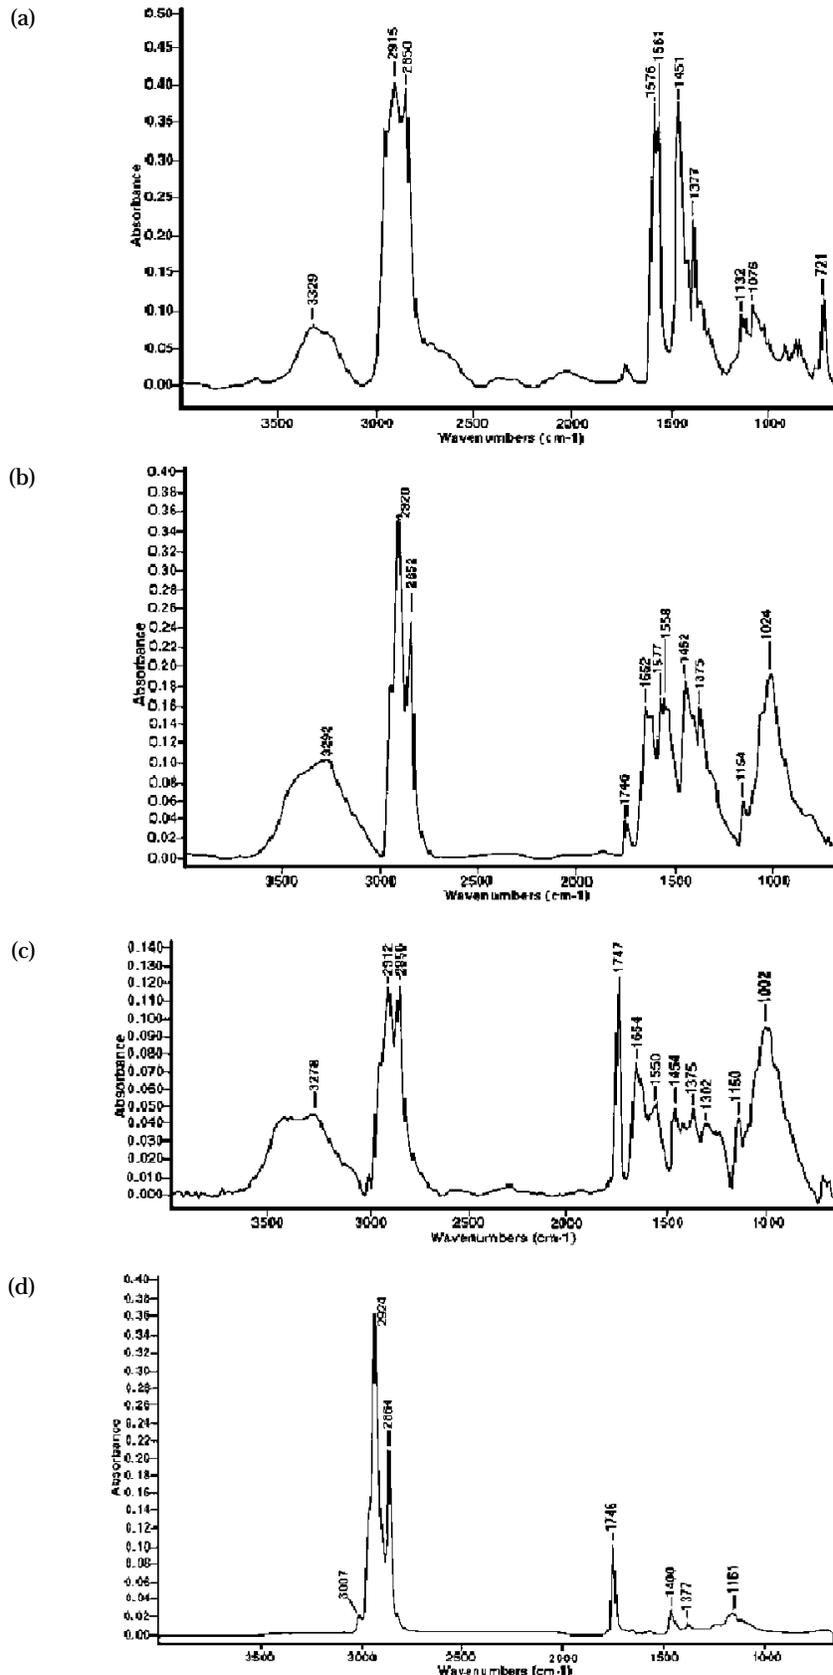
order of increasing degradation (Fig. 4 a-d). The broad peak at 3300-3200 wavenumbers is indicative of bonded hydroxyl groups, such as those found in hydroxy acids. Peaks immediately below 3000 wavenumbers (2924-2850) are typical of hydrocarbons and are due to methyl and methylene groups. The peak for bonded-OH in carboxylic acids is in the same region. Peaks at 1000 wavenumbers are due to the presence of -C-O-C-bonding, a further indication of oxidation. As the grease is oxidized, the carboxylate contribution (1560 wavenumbers) decreases and the carbonyl contribution (1750 wavenumbers) increases. In Fig. 4a there is a strong carboxylate. In Fig. 4b the carbonyl contribution has increased and the carboxylate decreased. Peaks at 3200 and 1000 wavenumbers have increased. The effect is more pronounced in Fig. 4c. In all cases amide peaks are prominent. In Fig. 4d the spectrum indicates the presence of light oil. The carboxylate is missing and the carbonyl is prominent.

Fig. 4. (a) Grease and corrosion products; (b) Grease and corrosion products; (c) Grease and corrosion products; (d) Oily residue.

There were no indications of corrosion on two of the three control samples. A single site of localized corrosion was observed on one wire of an uninoculated control. Fungal hyphae were located in the corrosion products overlying shallow craters. There were no indications of chloride in EDS spectra of the grease. FTIR spectra for the degraded grease associated with the corrosion products were similar to those in Fig. 4.

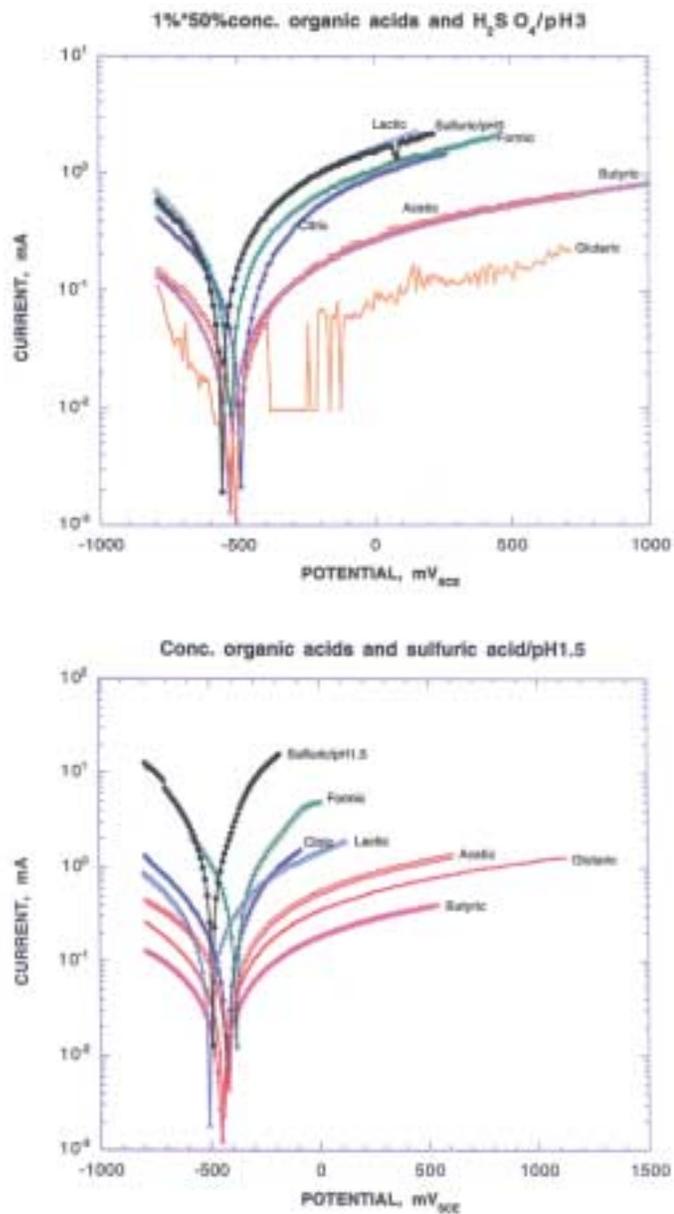
Polarization—Polarization curves demonstrated lack of passivity at all concentrations of all acids (Fig. 5 a-b). With time these curves can be expected to decay; however, time-dependent behaviors were not investigated. In the presence of sulfuric acid, corrosion currents calculated from the cathodic Tafel slope were 3.86 and 0.27 mA cm⁻² for pH 1.5 and 3.0, respectively. Table I summarizes the corrosion currents calculated in a similar way for the organic acids.

Fig. 5. (a) Polarization curves for 1% concentrated organic acids and sulfuric acid at pH 3.0; **(b)** Polarization curves for concentrated organic acids and sulfuric acid at pH 1.5.

Currents varied among the organic acids. Both formic and lactic acids at 1% concentration produced corrosion at approximately the same rate as sulfuric acid at pH 3.0.

Acids produced by fungi are damaging to metals, glass, masonry, and other materials.¹³⁻¹⁸ The acids most frequently cited as being produced by fungi are formic, citric, and acetic. H₂SO₄ at pH 1.5 exhibits a corrosion current of 3.86 mA cm⁻² which is a little more than twice that for formic acid. For the 1% organic acid solutions, the corrosion currents for the organic acids ranged from 0.27 to 0.03 mA cm⁻² and the H₂SO₄ at pH 3.0 exhibits a corrosion current of 0.27 mA cm⁻². These are generally lower than for concentrated solutions. The magnitude of the corrosion currents is sufficient to produce significant corrosion in steel. The open circuit potentials for the concentrated solutions are generally higher than for the 1% solutions. This follows from the fact that the slope of the standard hydrogen line is 0.060 mV per pH unit.
