Investigating Changes In The Corrosion Mechanism Induced By Laser Welding Galvanised Steel Samples Using SVET

H.N. McMurray, J.R. Searle, B.P. Wilson and D.A. Worsley.

Engineering Doctorate Centre for Steel Technology,
Department of Materials Engineering, University of
Wales, Swansea, Singleton Park Swansea, UK SA2 8PP

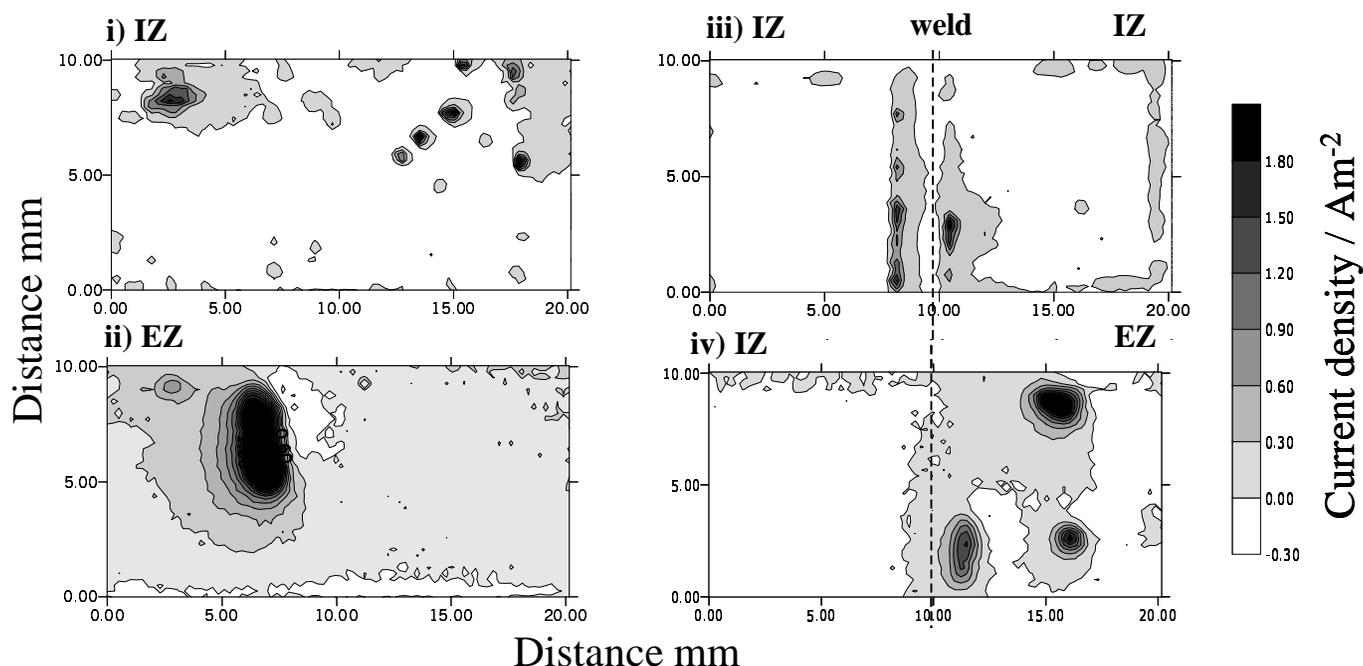
Figure 1. Iso-current contour plots of the normal component of current density derived from SVET scans above (i) flat galvanized (IZ) (ii) flat electro-zinc (EZ) (iii) Laser welded galvanized (IZ:IZ) and (iv) Laser welded galvanized: electro-zinc (IZ:EZ) samples freely corroding in 0.86 mol dm⁻³ neutral aerated aqueous NaCl at 20°C. Data presented is after 1-hours exposure.

On flat galvanized (IZ) samples anodic events are highly localised and occur at random over the exposed sample surface during a 24-hour immersion period. This reflects the progressive de-zincification of zinc rich areas of the iron zinc intermetallic coating. By contrast on flat electroplated zinc (EZ) samples anodic activity is

localised but corrosion initiates at a single anodic centre, which eventually spreads out to form a scar on the metallic surface. This concentration of anodic activity on the sample leads to greater dezincification than for the IZ coating. The integrated SVET data was used to provide an estimate of the total zinc loss from the exposed area on the coupons of 277µg cm⁻² for EZ and 118µg cm⁻² for IZ respectively.

Laser welded samples were prepared by joining IZ to IZ and IZ to EZ coated 1.2 mm steel panels. A 2 cm² exposed area was investigated using SVET with *ca* 1cm² exposed either side of the weld. The joining of IZ samples together using a laser weld changes the localisation of anodic activity in neutral aerated sodium chloride solution dramatically. In this instance focal anodes initially concentrate proximal to the weld area in a zone enriched in zinc (and depleted in iron) as a result of the welding process. This localisation of anodic and cathodic activity proximal to the weld reduces the anodic damage on the IZ remote to the heat-affected zone over the 24 hours exposure period but overall zinc loss was 95 µg cm⁻², similar to the non-welded case. When samples of EZ and IZ are laser welded together, galvanic coupling leads to all anodic activity becoming focussed on the EZ samples with a total zinc loss over 24 hours from the exposed area measured as 245 µg cm⁻² very close to that of the zinc loss from the EZ sample alone. By contrast there is no measurable zinc loss from the IZ portion sample under these conditions. The focal activity on the EZ results from it containing no iron whatsoever. This work illustrates the potential for inducing corrosion failure by mixing metallic coating types in tailor welded blank assemblies.
