Chlorine Corrosion of Aluminum Interconnect from Laser Activated Parylene in Acoustic MEMS Arrays

Xerox Palo Alto Research Center
3333 Coyote Hill Road
Palo Alto, CA 94304

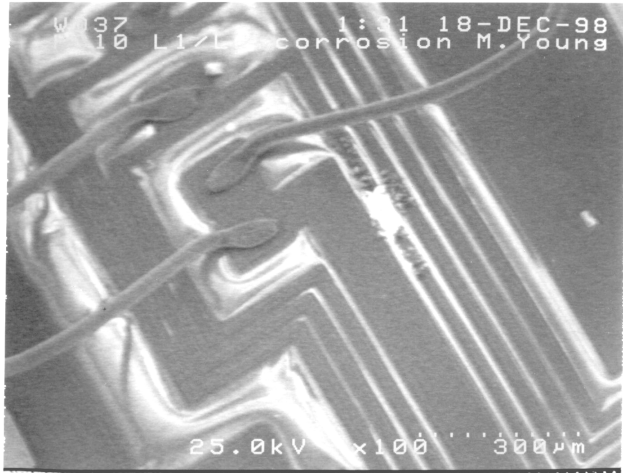
Figure 2. Scanning Electron Micrograph of Aluminum trace corrosion.

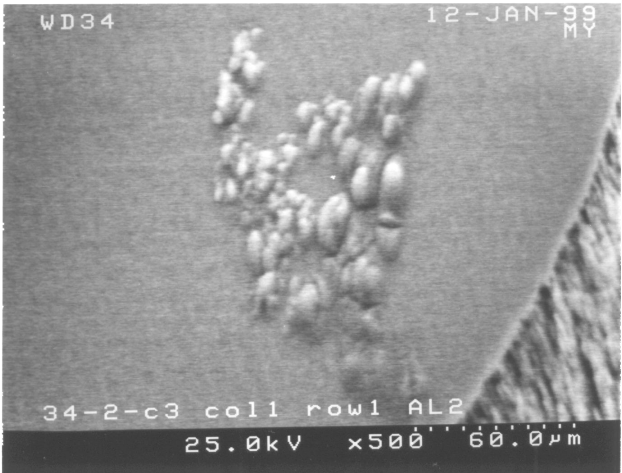
Figure 3. Scanning Electron Micrograph of Aluminum corrosion on ZnO transducer electrode.
