Dioxygen Reduction at AA2024 Causes Base-Induced Loss of Passivation

Jesse Seegmiller, Reinaldo Bazito and Daniel A. Buttry*
Department of Chemistry, University of Wyoming,
Laramie (WY), 82071-3838, USA

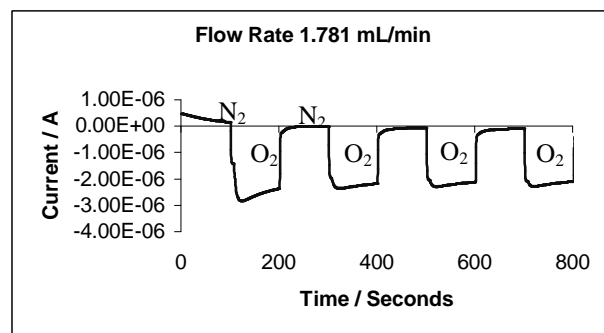
Figure 1 Time dependent current in wall-jet flow cell at AA2024 sample. Flow is alternated between N_2 -saturated and O_2 -saturated buffer solution (80 mM BES, pH 6.5), showing repeatability. O_2 reduction current is 13 microamp/cm².

AA2024-T3 samples were cleaned and polished using standard procedures, except that polishing was done in aprotic solvents to inhibit corrosion during the polishing. The reduction of dioxygen at the alloy surface was studied in a wall-jet flow cell [3]. Figure 1 shows the current observed for an experiment in which the AA2024 substrate was held at a potential of -0.95 V vs. SCE and the flow was alternated between N_2 -saturated and O_2 -saturated buffer solutions. The diffusion-limited reduction current for dioxygen at the AA2024 surface was 13 microamp/cm². Calculations will be presented that show this current to be in good agreement with expectations for an array of microelectrodes (i.e. the micron-sized intermetallic particles). Under unbuffered conditions, the observed currents are much larger, in the range of hundreds of microamps/cm², and much less stable. These much larger currents result from wholesale attack by hydroxide at the surface, where the hydroxide is the product of dioxygen reduction. No attack is observed in the absence of O_2 . Figure 2 shows a scanning electron micrograph of the surface after a limited period of attack of the surface by hydroxide produced *via* reduction of dioxygen. The image clearly shows attack around both the Fe-rich and Cu-rich inclusions as well as pitting at various locations across the surface. These results and other details of these measurements will be discussed in this presentation.

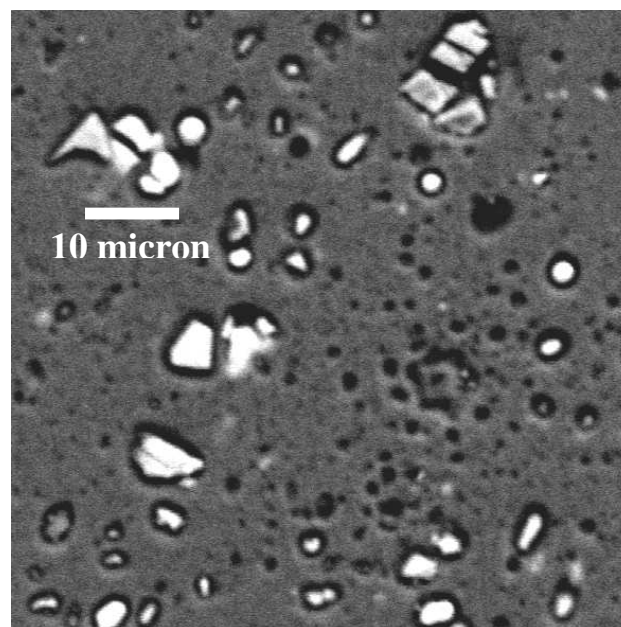
Figure 2 - SEM image of AA2024 surface showing hydroxide-induced trenching around both the Fe-rich and Cu-rich intermetallic inclusions. Note also substantial pitting across the surface.
